FIELD INVESTIGATION TEAM ACTIVITIES AT UNCONTROLLED HAZARDOUS SUBSTANCES FACILITIES — ZONE I

PRELIMINARY ASSESSMENT OF
VALMONT SITE
PREPARED UNDER

TDD NO. F3-8904-12
EPA NO. PA-2245
CONTRACT NO. 68-01-7346

AUGUST 18, 1988

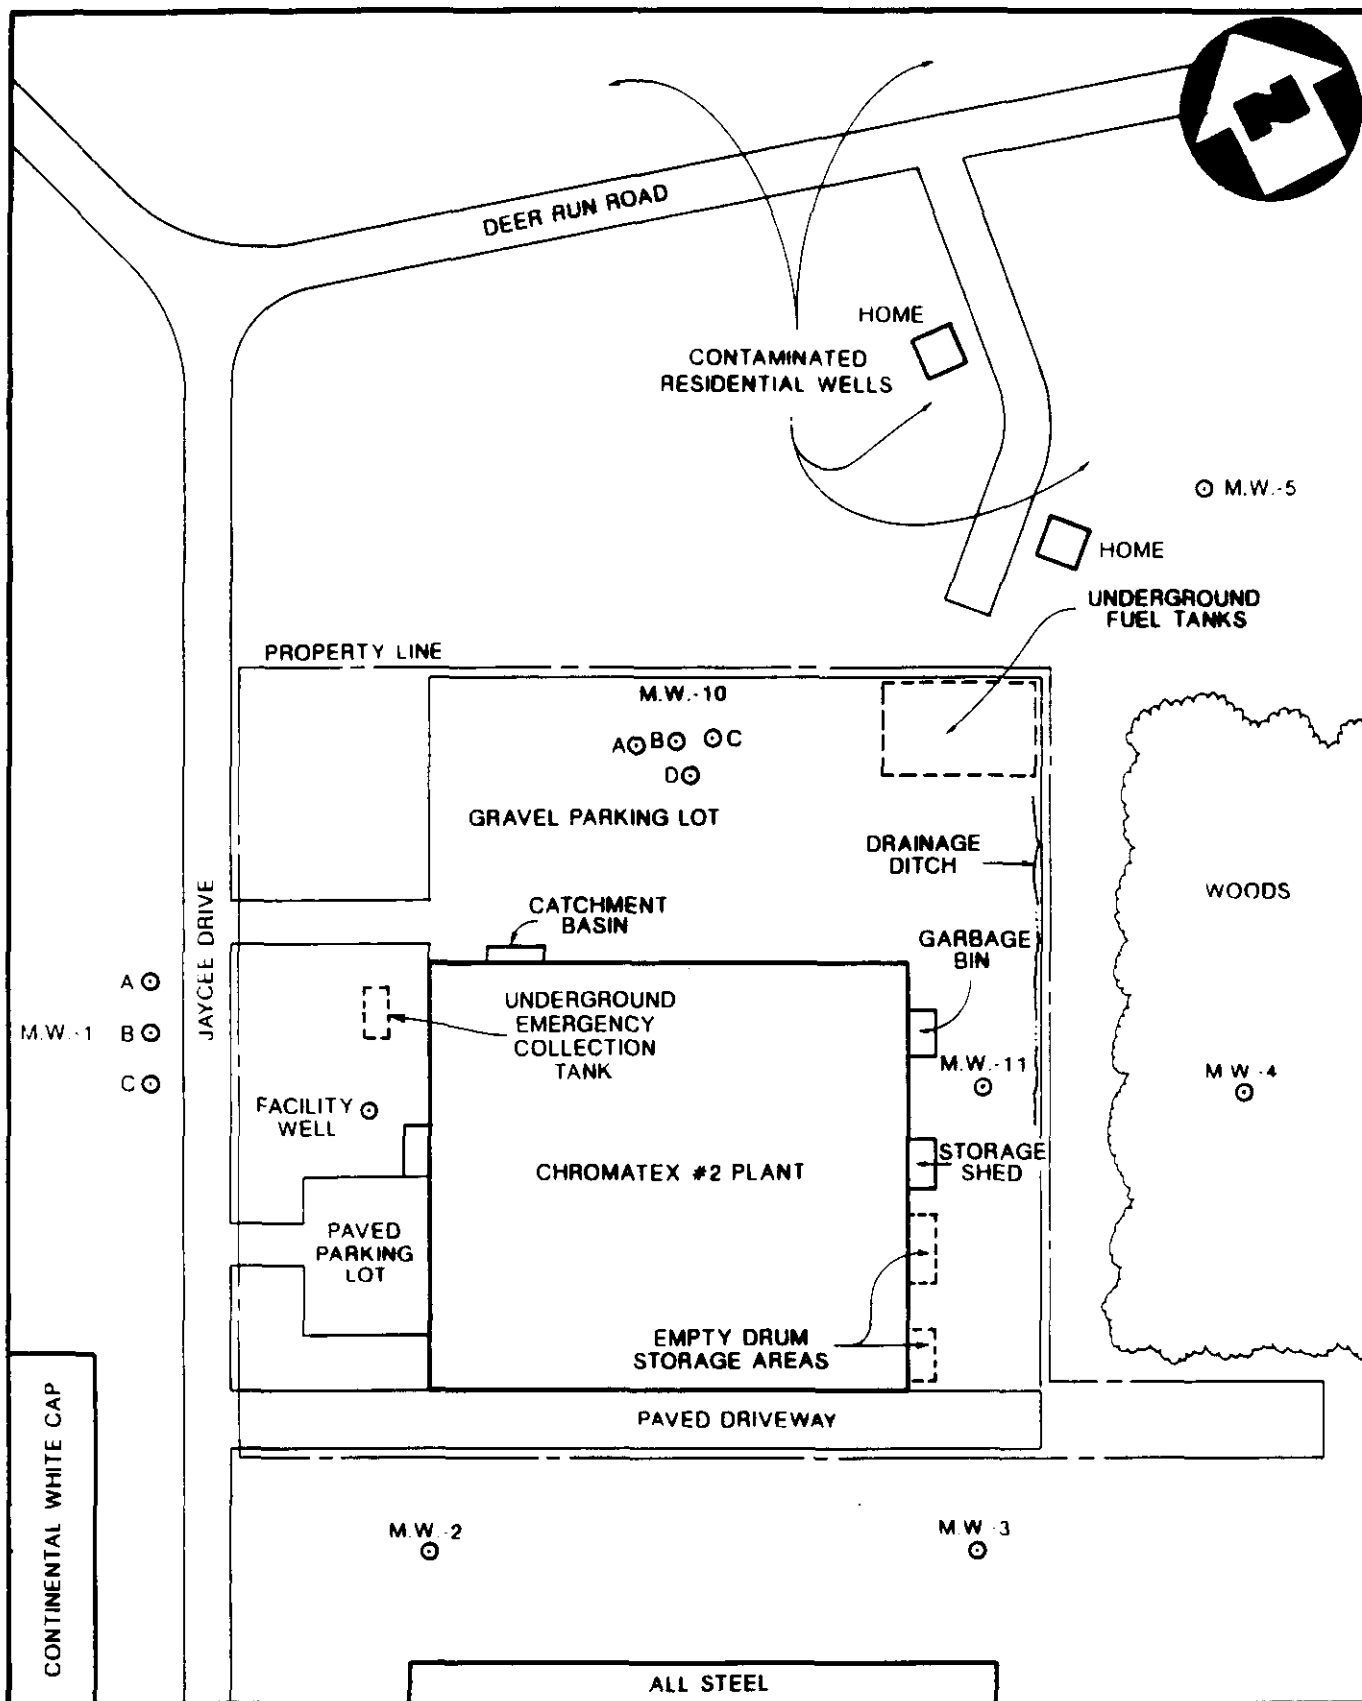
FIGURE 2.2

The site includes one large building that has several attachments. The northeastern side of the building contains a truck loading area and a catch basin, where chemicals that are spilled while being pumped into storage tanks are collected. A gravel parking lot is adjacent to the northeastern side of the building. Underground fuel oil tanks are located approximately 150 feet north of the eastern corner of the building. A monitoring well cluster containing 4 wells is located 175 feet northeast of the northeastern side of the manufacturing building (see figure 2.2, page 2-3).²

The southeastern side of the building contains a storage shed, a garbage bin, and an empty drum storage area. Two monitoring wells are located approximately 15 and 225 feet from the southeastern side of the building (see figure 2.2, page 2-3). A drainage ditch, originating near a roof-top drainpipe between the storage shed and the garbage bin, travels parallel to the southeastern side of the building in a northeastward direction. Two areas along the southeastern side of the building are used for empty drum storage. One area is located approximately 15 feet southwest of the storage shed; the second area is located near the southern corner of the building, along its southeastern side. These drums reportedly contained lubricating oil and well cuttings from the installation of the monitoring wells.^{2,3}

Based on these preliminary results, an extent of groundwater investigation was undertaken, which involved the construction of 11 monitoring wells (see figure 2.2, page 2-3). Information concerning the monitoring wells can be found in table 1 (page 2-7), and sample results are summarized in table 2 (page 2-8). The extent of contamination study revealed that a major source of the groundwater contamination is located near monitoring well no. 11, near the eastern corner of the Chromatex building, and that the contamination in the residential wells did not originate from the underground storage tank.¹³

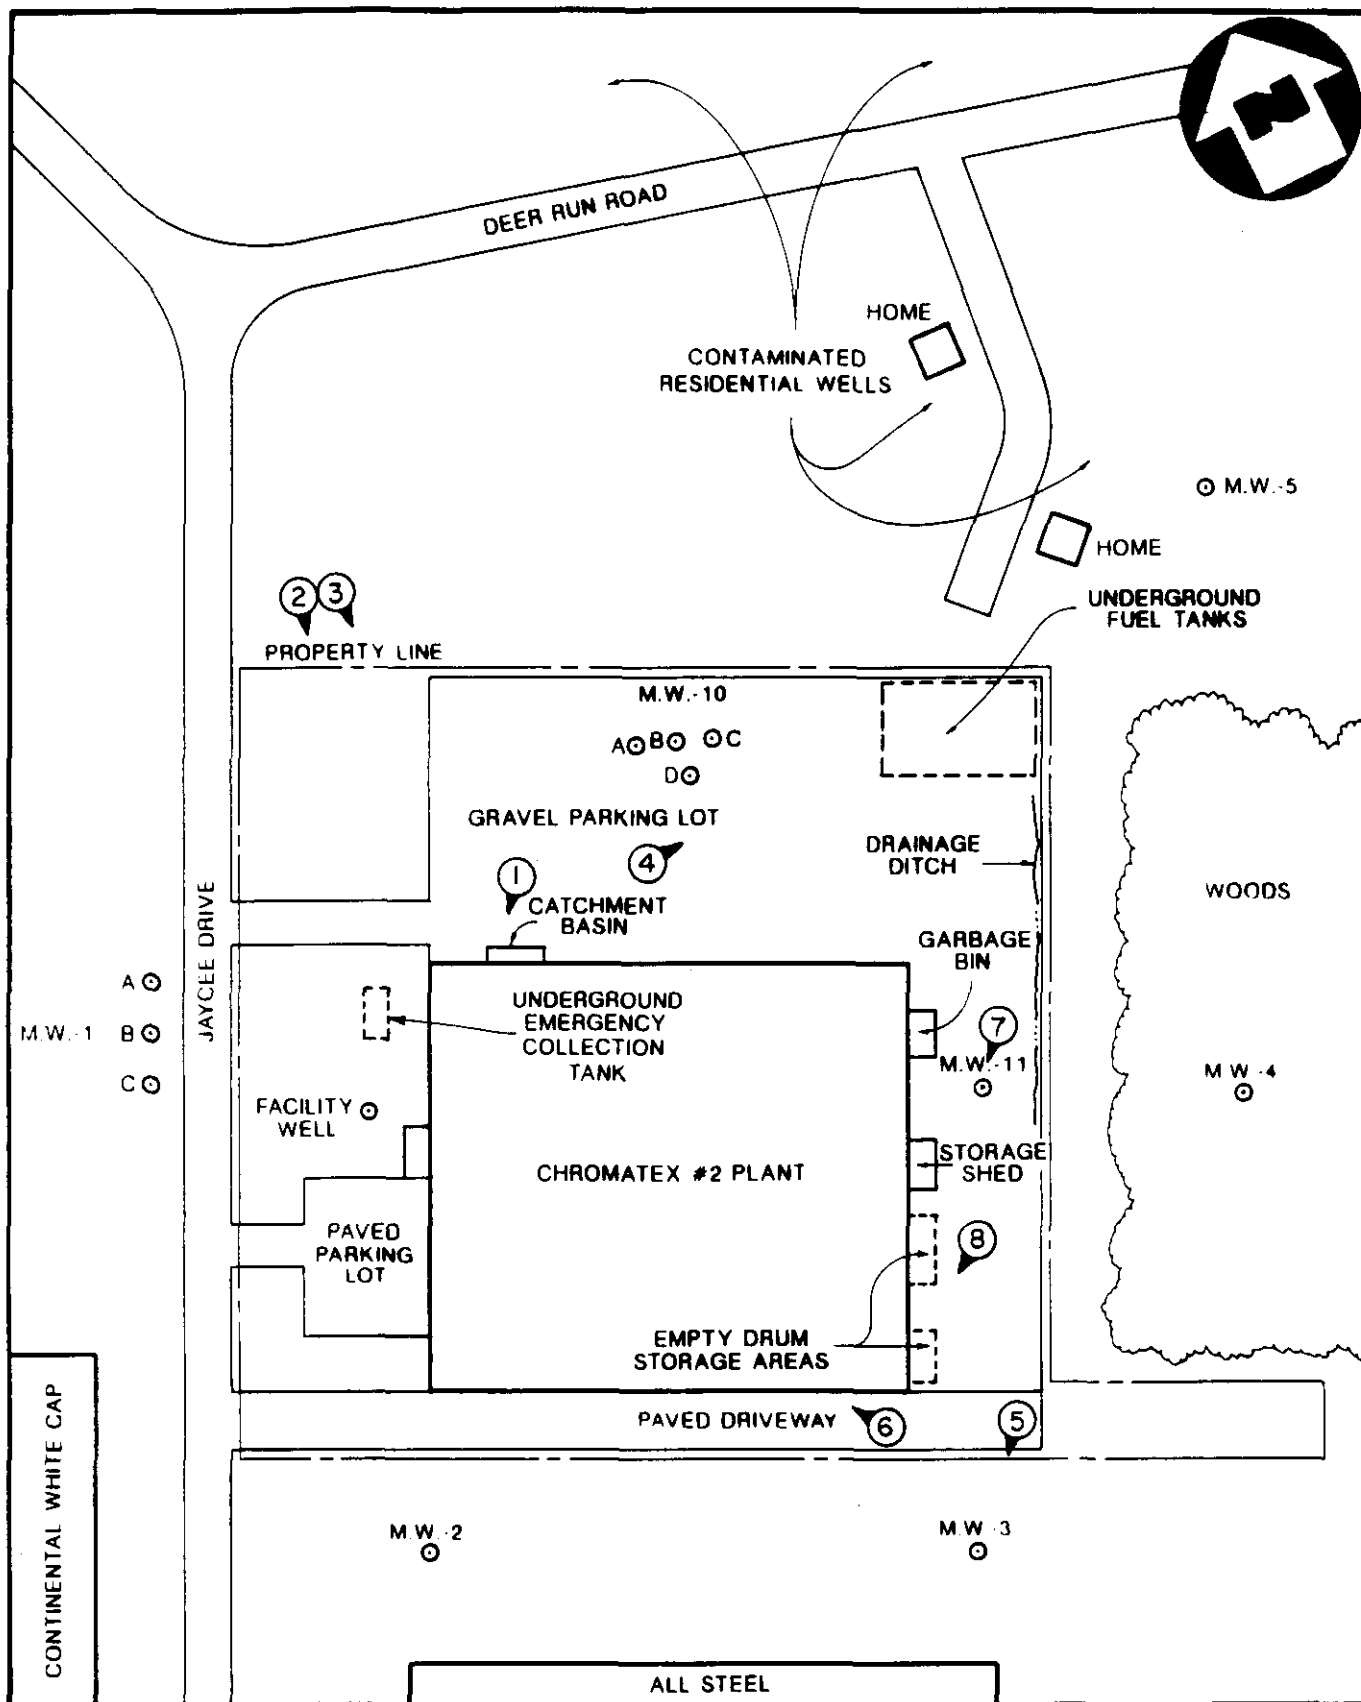
FIGURE 5.1

- A spill basin was located on the northeastern side of the building, where TCE was pumped into two 5,000-gallon above-ground storage tanks.
- There were two areas of empty drums along the southeastern side of the building. The labels on the lids of several drums indicated that they contained some type of lubricating oil.

- An underground storage tank was located in an area of excavation near the northern corner of the building.
- A roof drain was located near the eastern corner of the building, between a storage shed and a garbage bin.
